Vassar College

Getty Foundation Campus Heritage Grant

Historic Preservation Design Manual

June 15, 2007

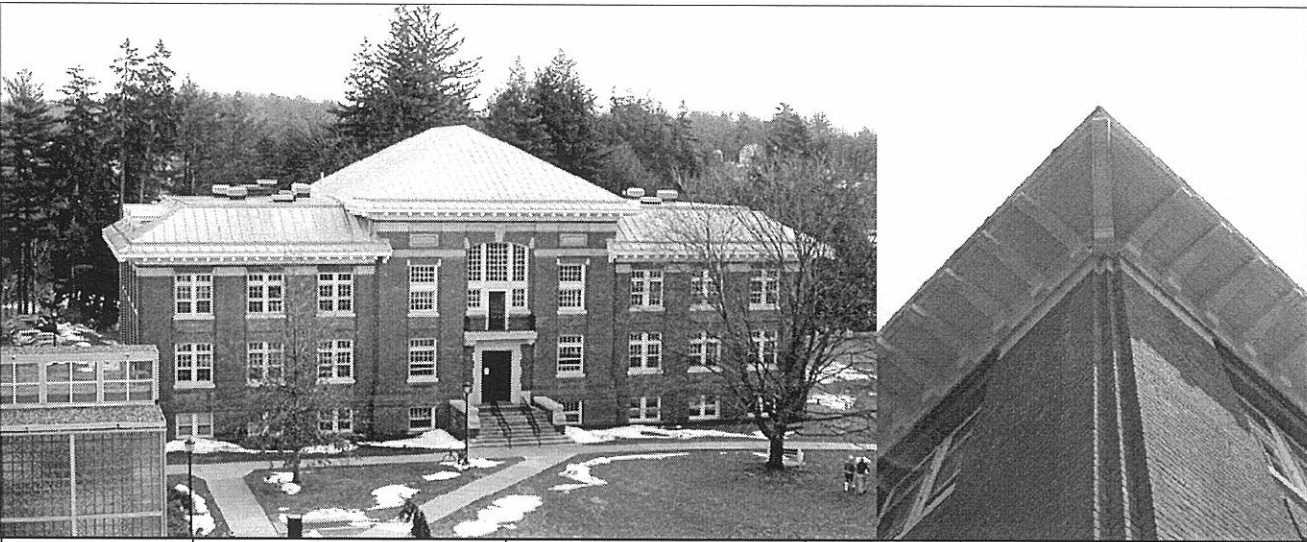
Item	Year of Installation	End of Service Life Year				2007	2008- 2010	2011- 2016	2017+		
1	Roof Construction														
1a	Pitched Roof	Batten-seam lead/tin-coated steel (terne) with elastomeric coating	Fair-Poor	Elastomeric coating	1990	2008	Weathertight; draining	Limited review, 2004. Minor repairs, 2005.	Replace at end of service life.		X			75	Installation of coating has extended service life of perforated terne roof. For reduced maintenance, consider copper replacement.
				Hipped and mansard slopes.	1909										
1b	Low Slope	Fully adhered EPDM system	Excellent	Both areas.	1990	2010	Weathertight, aesthetically pleasing.	Limited review, 2004. Localized repairs, 2005.	Continue maintenance until roof replacement.	X	X			30	Original flat seam roof may still be under EPDM.
1c	Other, Gutter	Built-in, EPDM-lined.	Fair-Poor	All slopes.	1990	2010	Weathertight, Draining	Limited review, 2004. Minor repairs, 2005.	Continue maintenance until roof replacement.	X	X			50	Replace EPDM with copper lined system for enhanced durability.

1d	Other, Dormers	Flat-seam terne roofed dormers with an elastomeric coating.	Good-Fair	All dormers	1909	2008	Weathertight, Draining	Limited review, 2004 & 2006.	Replace roof systems when entire roof replaced.					60	
1e	Other, Chimneys	Stucco clad brick masonry with terra cotta flues.	Good-Fair	East elevation.	1901	Unlimited with maintenance.	Weathertight, Draining	None	Restore missing elements and repair open seams and breaches.		X			Unlimited with maintenance.	
1f	Other, Soffit	Painted wood with brackets.	Good-fair	All elevations.	1901	Unlimited with maintenance.	Weathertight.	None	No recommended action.					Unlimited with maintenance.	
2	Exterior Walls Construction														
2a	Mass Masonry Composite	Brick Masonry	Good	All elevations.	1909	Unlimited with maintenance.	Weathertight, structurally sound, clean	Limited review, 2004.	No recommended action.					Unlimited with maintenance.	Wide soffit shields walls from direct water exposure.

2b		Limestone	Good												
3	Windows														
3a	Fixed & Operable	Composite wood sashed, single-hung assemblies.	Good	All units.	1901	Unlimited with maintenance.	Weathertight, optically transparent.	Minor review, 2003.	Paint system renewal.		X			Unlimited with maintenance.	Coordinate with roof rehabilitation project.

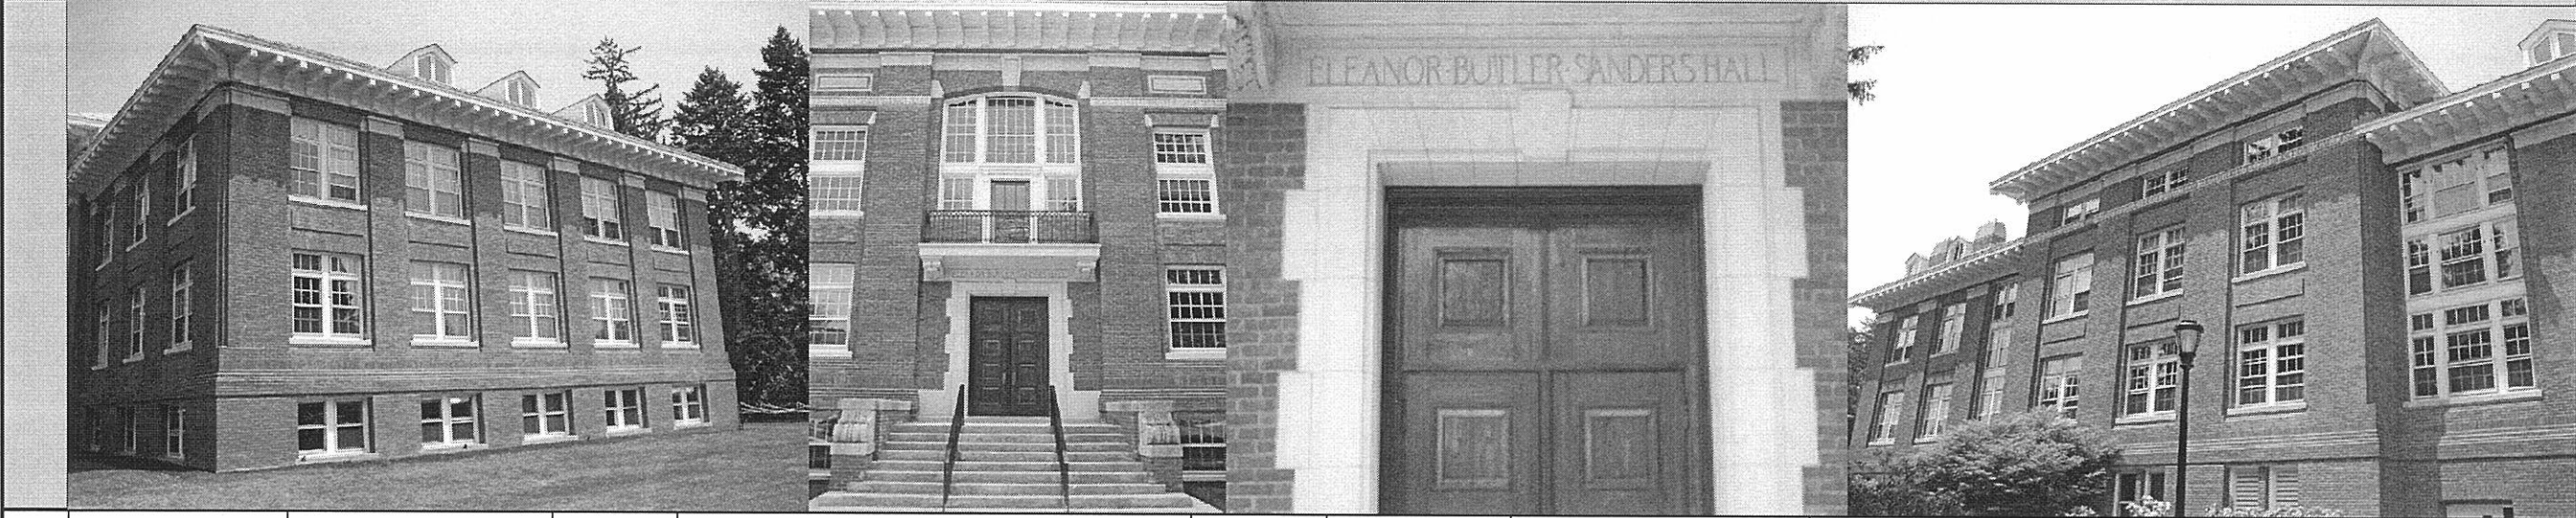
18 Sanders Classroom

Item No.	Building Component	Original Description	Existing Condition	Condition Description			Goals	Investigations/ Repairs	Options	Priority- Recommended Intervention Time Frame				Repair/ Replacement Anticipated Life (Yrs)	Recommendation/ Comments
				Item	Year of Installation	End of Service Life Year				2007	2008- 2010	2011- 2016	2017+		
4	(Other Building Components- as required)														
4a	Main entrance	Limestone assembly.	Good	West elevation.	1901	Unlimited with maintenance.	Weathertight, structurally sound, aesthetically pleasing.	Limited review, 2003	No recommended action.

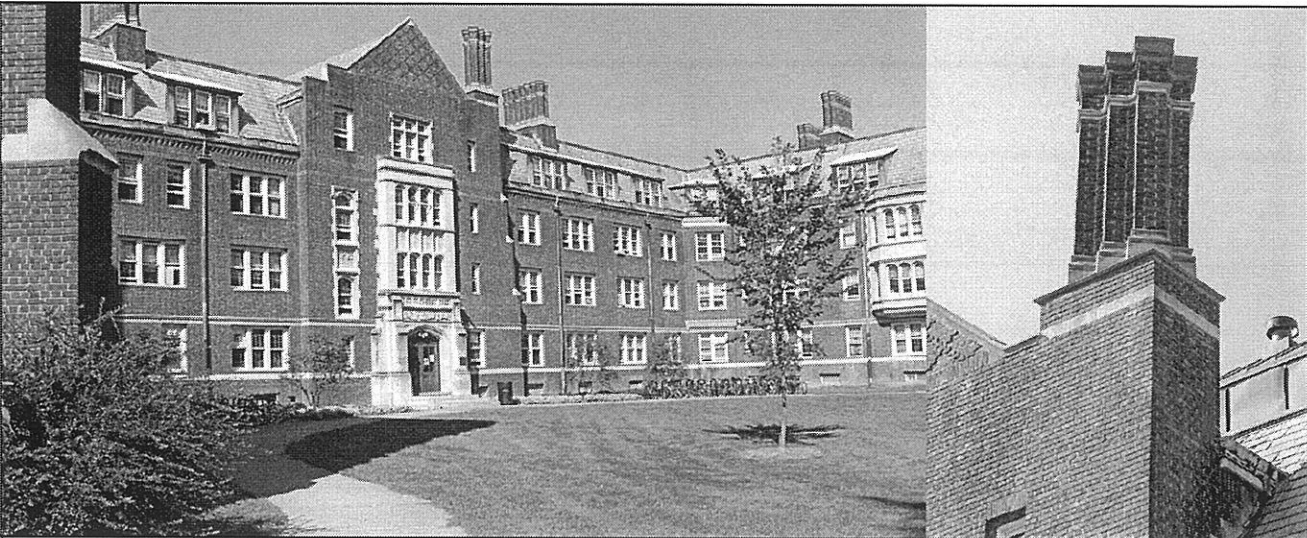
Item	Year of Installation	End of Service Life Year				2007	2008- 2010	2011- 2016	2017+		
1	Roof Construction														
1a	Pitched	Higher sloped mansard, unfading green slate with uniform exposure.	Good-fair	All slopes	1912	2009	Weathertight	Minor review, 2003, and limited repairs in 2005, 2006.	Replace as part of roof rehabilitation program.		X			125+	
		Copper flashings and hanging gutter system.	Fair-Poor	All slopes	1912	2009	Weathertight, draining.	Minor review, 2003, and limited repairs in 2005, 2006.	Replace as part of roof rehabilitation program.		X			60	
1b	Low Slope	Adhered EPDM.	Fair	Central low slope areas and tower	1980	2009	Weathertight, draining.	Minor review, 2003, and repairs in 2005, 2006.	Replace as part of roof rehabilitation program.		X			Depends upon selected replacement system.	
1c	Other, Chimneys	Brick masonry with limestone trim elements.	Good-fair	All chimneys	1912	Unlimited with maintenance.	Weathertight, structurally sound.	Minor review in 2004.	Repoint and reseal as part of roof rehabilitation program.		X			Unlimited with maintenance.

1d	Other, Dormers	Standing seam copper.	Fair	All slopes	1912	2009	Weathertight, draining.	Minor review, 2003, and repairs in 2005, 2006.	Replace as part of roof rehabilitation program.		X			60	
2	Exterior Walls Construction														
2a	Mass Masonry, Composite	Typical walls: brick masonry.	Good-fair	All elevations	1912	Unlimited with maintenance.	Weathertight, structurally sound.	Limited review, 2003, and minor repairs to remove life-safety spalls in 2004. Window lintel review in 2007.	Steel plates embedded in reinforced concrete window lintels are corroding and damaging masonry. Structurally reinforce, remove the plates, and restore the local masonry.		X			Unlimited with maintenance.	
		Typical walls: limestone trim elements.	Good			Unlimited with maintenance.	Weathertight, structurally sound.				X

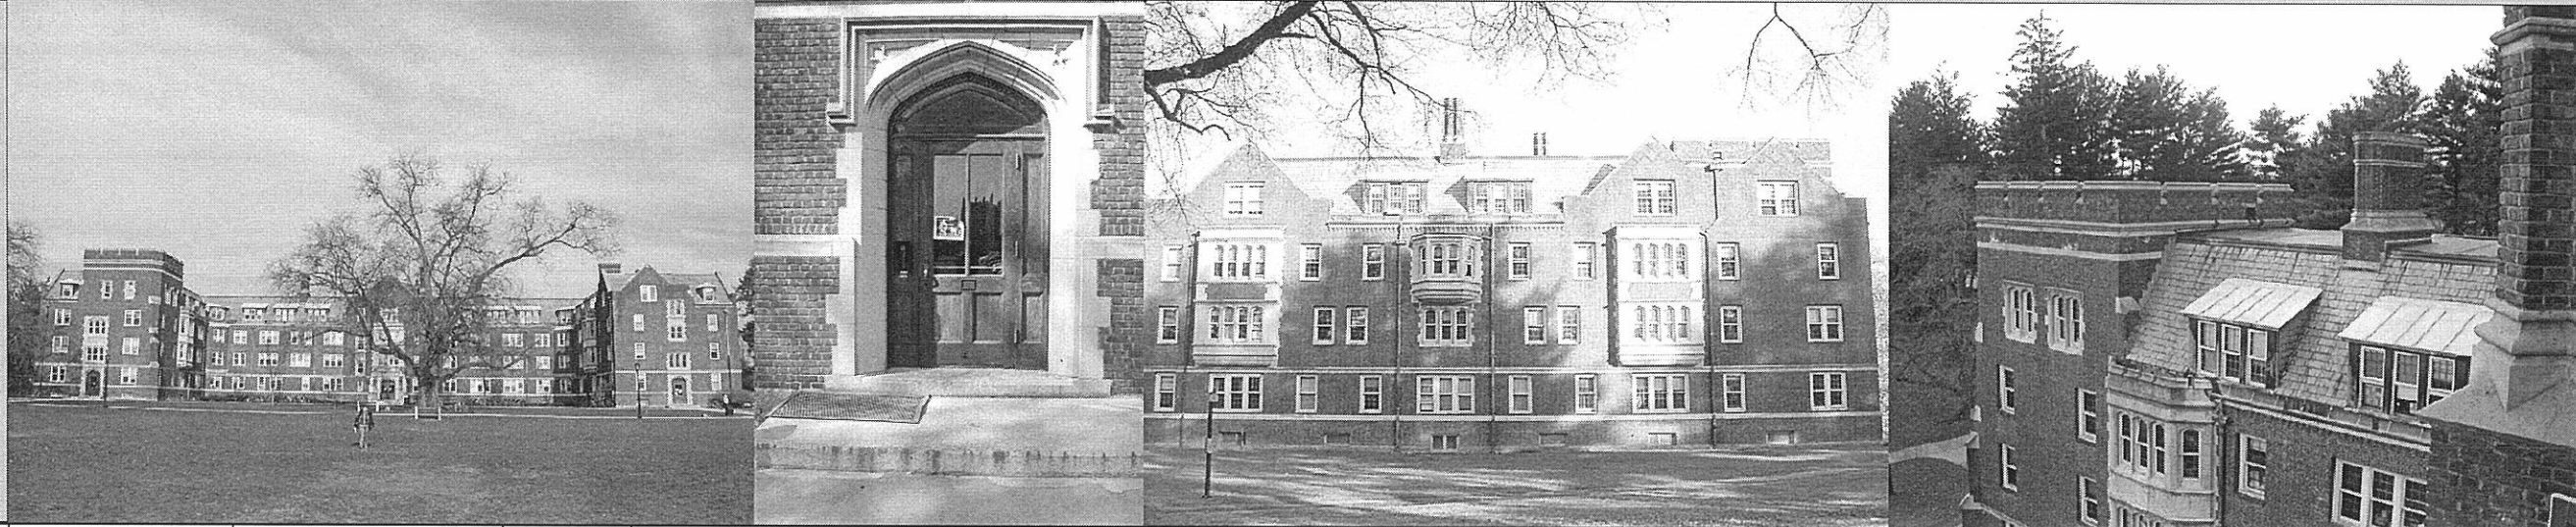
19	Olivia P. Josselyn House

Item	Year of Installation	End of Service Life Year				2007	2008- 2010	2011- 2016	2017+		
3	Windows														Windows
3a	Operable, single-hung	Leaded glass in painted wood frames and sashes.	Fair-poor	General elevations	1912	Unlimited with maintenance.	Weathertight, aesthetically pleasing.	Minor review, 2003.	Either repair windows during building envelope renewal program for 20 yrs, or replace with new units.		X			Depends upon selected replacement system.	Frames and sashes, etc. require periodic maintenance, and painting every 10 years to remain in servicable condition.
3b	Fixed	Leaded glass in painted wood frames and sashes.	Fair-Poor	General elevations							X				
4	(Other Building Components- as required)														(Other Building Components- as required)
4a	Entrances	Decorative limestone surround with granite base.	Good	South Main Entrance (Side Entrances)	1912	Unlimited with maintenance.	Weathertight, aesthetically pleasing.	Minor review, 2003.	No recommended action.

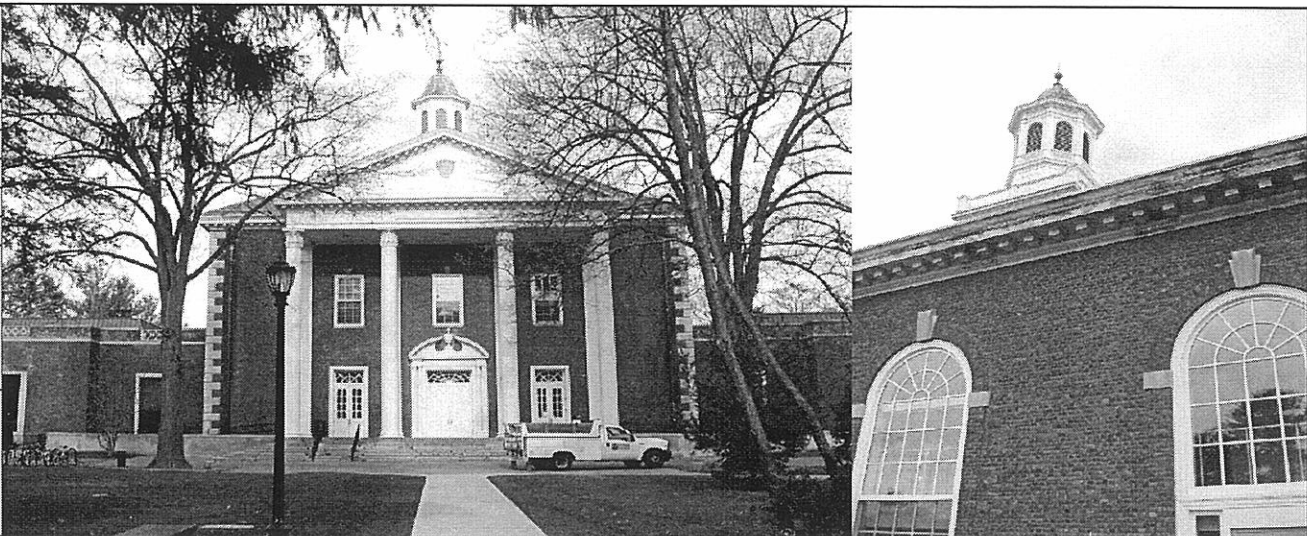
20	Students' Building (All Campus Dining Center) 1913

Item	Year of Installation	End of Service Life Year				2007	2008- 2010	2011- 2016	2017+												
1	Roof Construction															Roof Construction									
1a	Pitched Roof	Vermont purple and green slate roof areas	Fair-Poor	Hipped main roof	1913	2009	Weathertight; draining	Limited review, 2003. Minor repairs, 2005.	Continue repair of cracked and missing slates until roof replacement.			X		125+											
				Gabled portico roof.																					
1b	Other, Gutter	Built-in	Fair-Poor	All slopes.	1913	2009	Weathertight, Draining	Limited review, 2003. Minor repairs, 2005.	Replace with new roof.			X		50											
1c	Other, Soffit	Painted wood with brackets.	Fair	All elevations.	1913	Unlimited with maintenance.	Weathertight.	None	Rehabilitate during roof replacement.			X		Unlimited with maintenance.											
1d	Other, Cupola	TBD		Central hip roof.	1913	Unlimited with maintenance.	Weathertight, structurally sound.	None	Restore during roof replacement project.			X		Unlimited with maintenance.	Consider restoring cupula prior to implementing roof project.

1e	Low Slope	Ballasted EPDM	Fair	West and east additions, loading dock.	1995	2010	Weathertight; draining.	None	Replace when slate roof repkaced.			X		30											
1f	Parapet	Multi-wythe brick assembly, capped in precast concrete. Through-wall flashed with rainscreen.	Fair-Poor	West and east additions.	1973	Unlimited with maintenance.	Weathertight; draining.	Limited review, 2003.	Rehabilitate flashing details with localized rebuild to address water infiltration concerns.	X				Unlimited with maintenance.											
2	Exterior Walls Construction															Exterior Wall Construction									
2a	Mass Masonry Composite	Brick Masonry	Good	All original building elevations.	1926	Unlimited with maintenance.	Weathertight, structurally sound, clean	Limited review, 2003.	No recommended action.					Unlimited with maintenance.											
		Limestone	Good																						
2b	Cavity Wall	Brich veneer with concrete trim elements.	Good	All wing elevations.	1973	Unlimited with maintenance.	Weathertight, structurally sound, clean	Limited review, 2003.	Refurbish with parapet rehabilitation.	X				Unlimited with maintenance.

3	Windows															Windows									
3a	Fixed	Extruded aluminum framed assemblies.	Good	All units.	1973	Unlimited with maintenance.	Weathertight, optically transparent.	Minor review, 2003.	No recommended action.					Unlimited with maintenance.

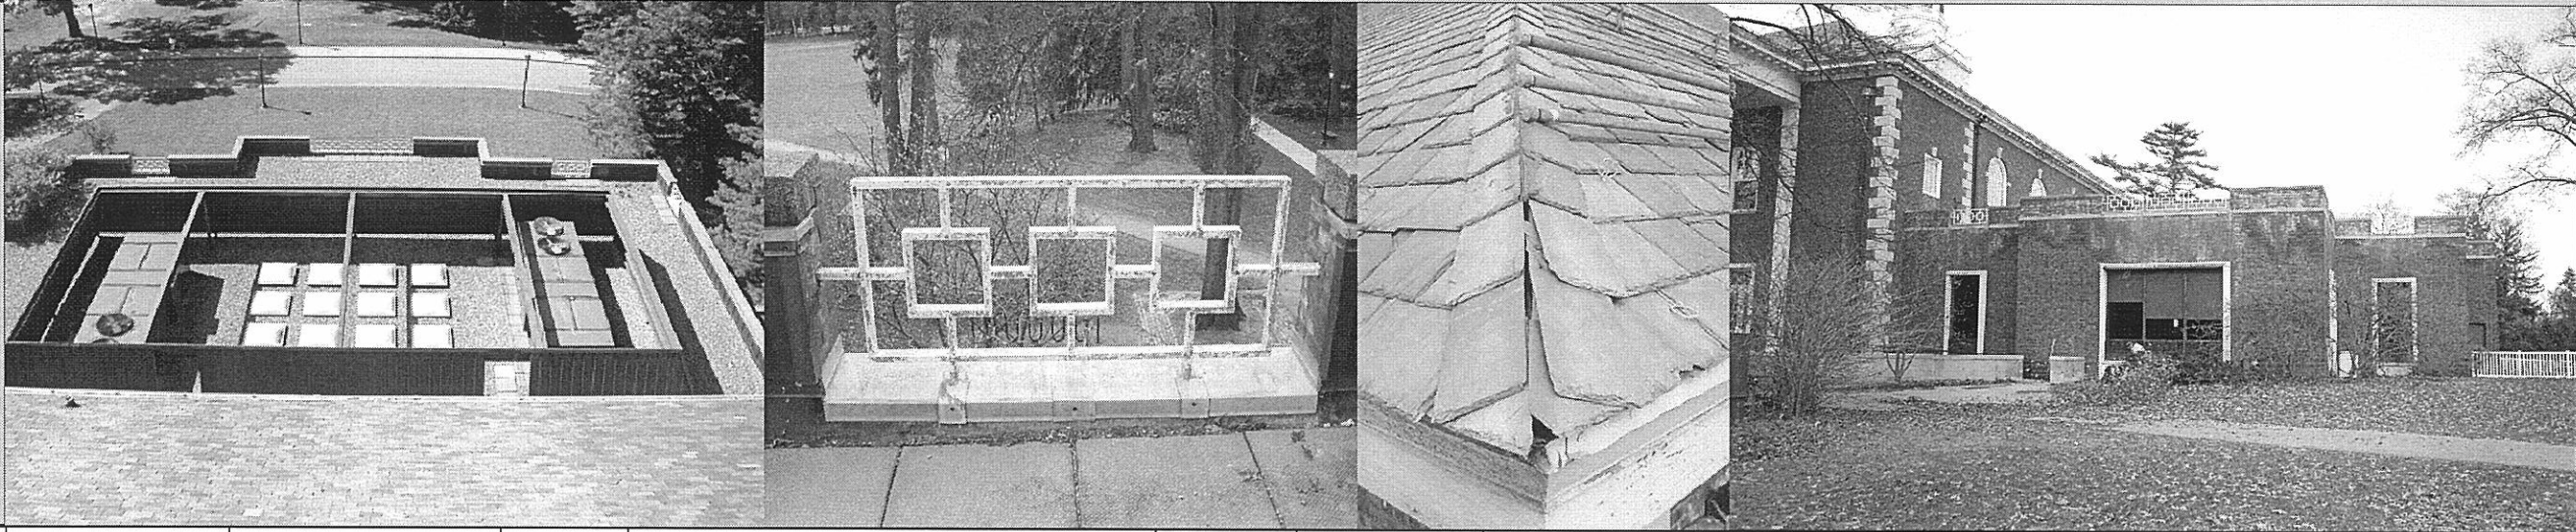
20 Students' Building (All Campus Dining Center)

Item No.	Building Component	Original Description	Existing Condition	Condition Description			Goals	Investigations/ Repairs	Options	Priority- Recommended Intervention Time Frame				Repair/ Replacement Anticipated Life (Yrs)	Recommendation/ Comments
				Item	Year of Installation	End of Service Life Year				2007	2008- 2010	2011- 2016	2017+		
4	(Other Building Components- as required)														
4a	Main entrances	Portico	Good-Fair	South elevation columns.	1913	Unlimited with maintenance.	Weathertight, structurally sound, aesthetically pleasing.	Limited review, 2003. Repairs, 2004.	Complete renewal of paint system for entire portico.	X					East-most column was banded with glass-fiber reinforced composite membrane strips to restore structural integrity.

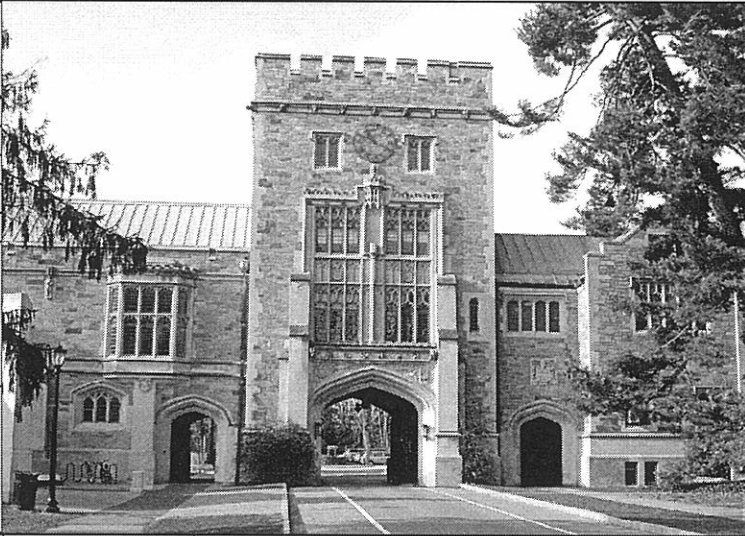
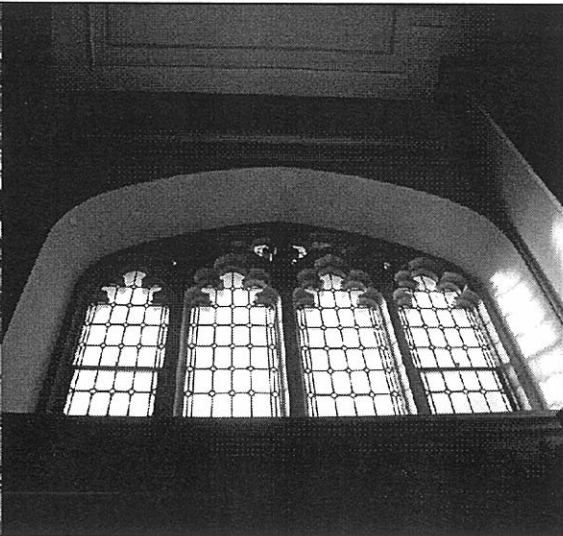
21	Taylor Hall 1915

Item	Year of Installation	End of Service Life Year				2007	2008- 2010	2011- 2016	2017+																						
1	Roof Construction															Roof Construction																			
1a	Pitched Roof	Batten seam copper system; presently coated with elastomeric system.	Poor	All slopes.	1915	1990	Weathertight	Limited review 2004.	Replace as part of full roof restoration.			X		75	Complete as part of comprehensive envelope restoration.																				
		Copper flashings.	Fair		1915	1990						X		60																					
1b	Low Slope	Unknown but presumed to be coal tar pitch.	Fair	All areas	1960	2010	Weathertight, Draining	None					X		40																				
2	Exterior Walls Construction															Exterior Wall Construction																			
2a	Mass Masonry, Composite	Typical walls: Dressed granite with brick backup.	Fair	Weathered mortar joints permits water to enter façade and cause damage to interior finishes.	1915	Unlimited with maintenance.	Weathertight, structurally sound.	Limited review, 2004.	Repoint in areas under limestone decorative courses.			X		100+	Complete as part of comprehensive mini-envelope restoration

Typical walls: Limestone trim elements	Poor	Mortar joints open, especially coping stones.	1915	Unlimited with maintenance.	Weathertight, structurally sound.	Limited review, 2004.	Repoint 100% to reduce water infiltration.			X		50+																					
3	Windows															Windows																			
3a	Fixed	Zinc-leaded glass in steel sashes and frames.	Fair	Isolated and rare broken lite in assemblies.	1915	2011	Weathertight, Structurally stable	Limited review, 2004	Restore or replace entire assemblies with broken lites.			X		90	Zinc, as a leading material is stronger and less susceptible to planar deflection than lead. However, given its higher strength and stiffness, it is harder to replace individual broken lites. As such, entire window sections must be undertaken to be cost-effective.																				
3b	Operable, Casement	Zinc-leaded glass in steel sashes and frames.	Fair	Isolated and rare broken lite in assemblies.	1915	2011	Weathertight, Structurally stable.	Limited review, 2004.	Restore or replace entire assemblies with broken lites.			X		90
